Translocation of freshwater pearl mussels (*Margaritifera margaritifera*) before habitat rehabilitation project : case study on the the Dronne River

Pichon C.
Parc naturel régional Périgord Limousin
La Barde 24450 La Coquille - France. Email : c.pichon@pnrpl.com

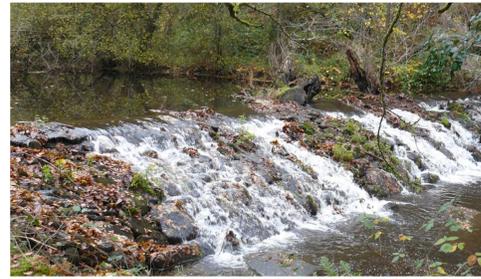
Figure 1 : Dam before restauration

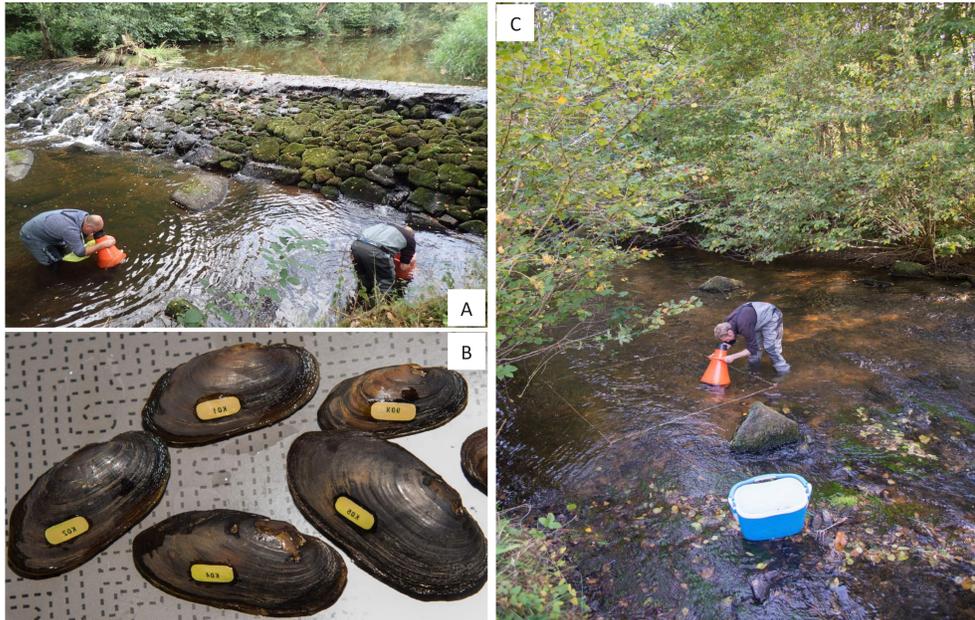
Figure 3 : Collection and handling in donor site (A), tagged mussels (B), placing mussels in plots in receptor site (C)

Two-metre-wide corridors are marked out on the donor site to enable a good coverage of the area. The surveys were carried out in two stages: all mussels detected using the bathyscope were collected and then, the substrate was carefully searched, with tools and by hand, to remove buried mussels. Part of the sediments was also sieved using 4 mm mesh; the process was repeated five times. Ten per cent of the translocated mussels were tagged. Mussels were then wrapped in a damp cloth and placed in a cool box to avoid shocks, dehydration and thermal shocks. The short distance to the translocation site (600 m upstream) was covered on foot. The mussels were placed in the substrate, in a natural position, using a trowel to open up a space in the gravels. Tagged mussels were distributed between the three plots on the translocation site, making sure not to destabilise the mussels already in place.
